QA-230
Locust Hill
Centreville
Private

INVENTORY FORM FOR STATE HISTORIC SITES SURVEY

Turpin House, Locust Hill

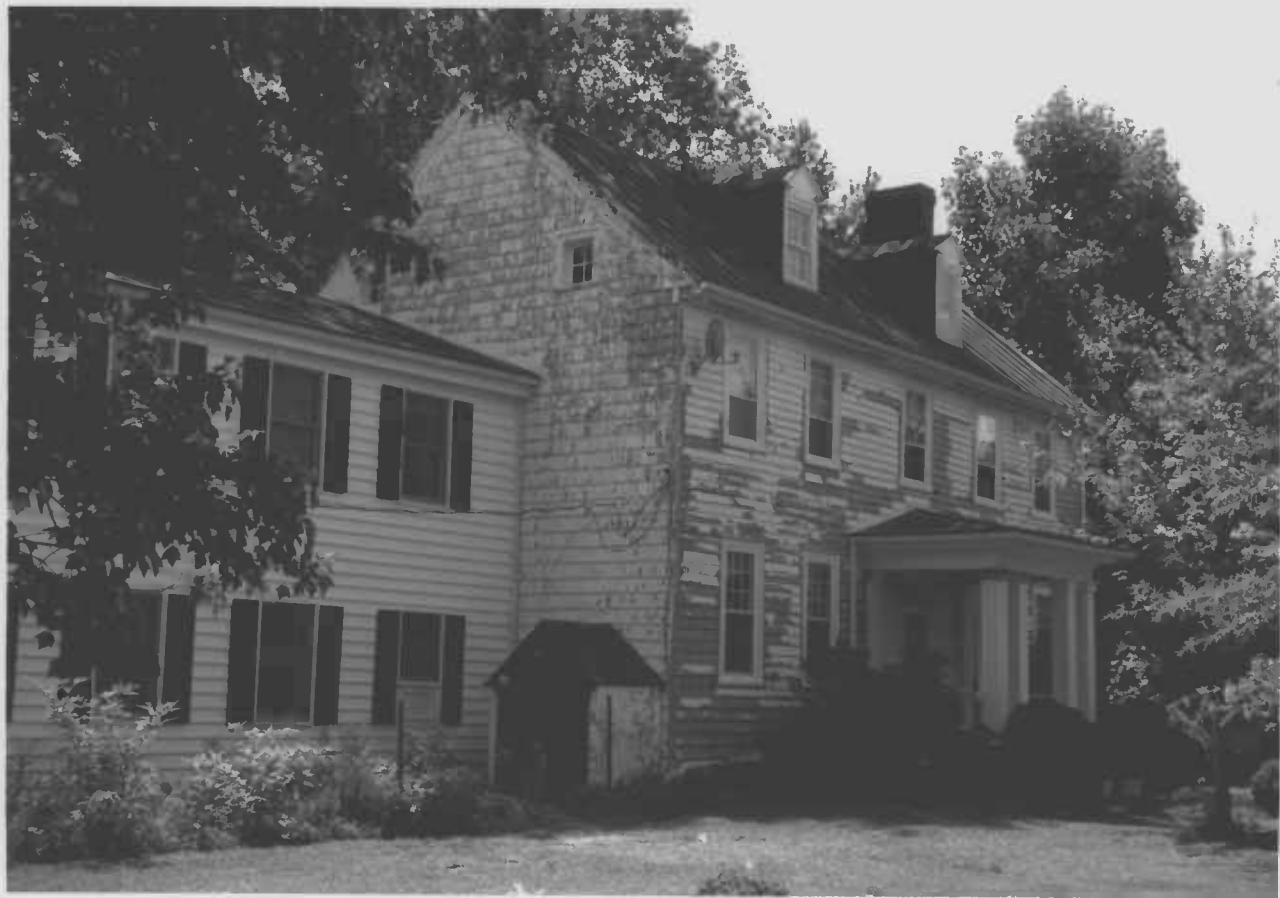
Main house + wing from Northwest
during preparations to paint exterior

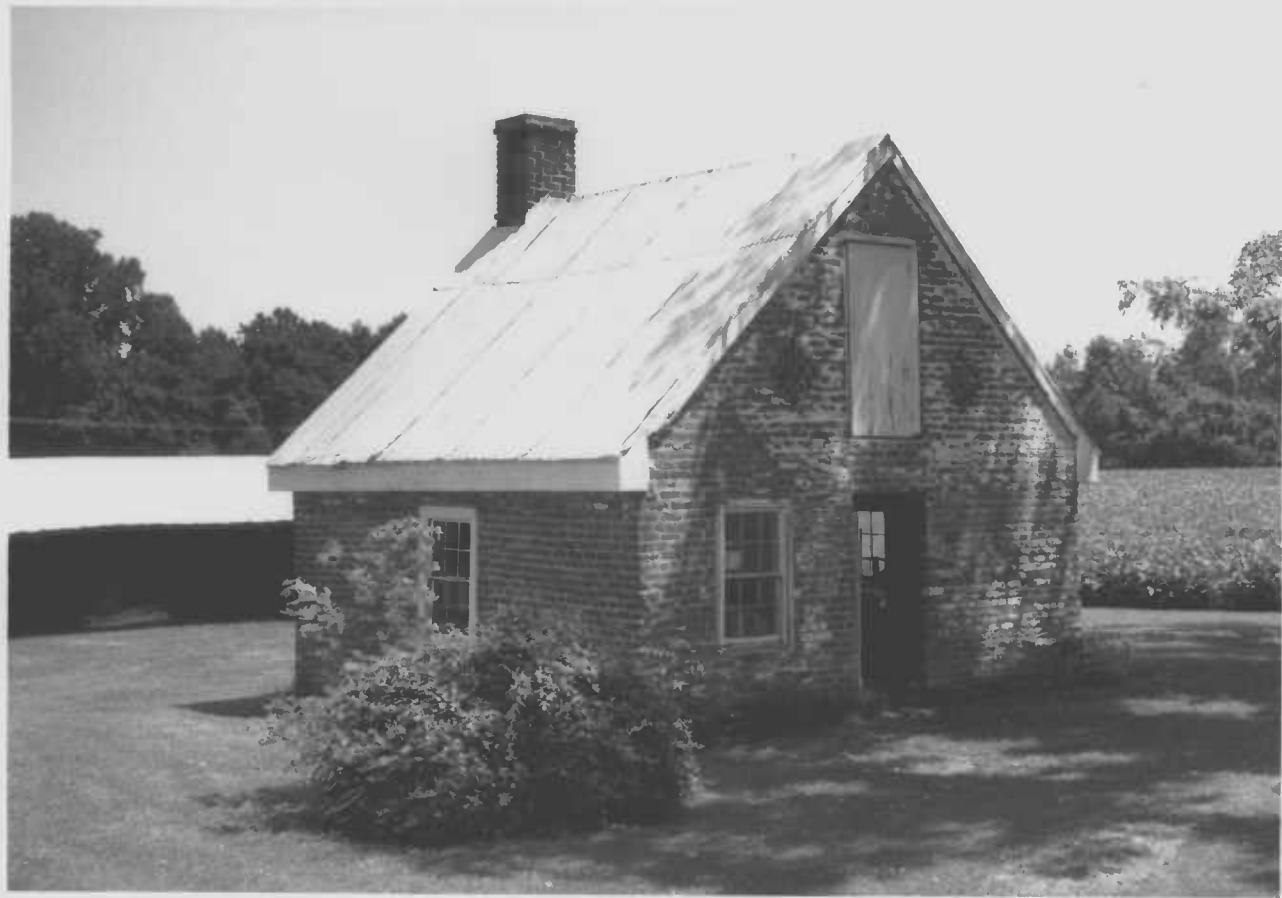
This building is approximately 18 1/2 feet square, with a pitched gable roof oriented on a north-south axis. It is constructed of three-course bond with a flush brick chimney centered on the north gable wall.

The principal entrance is centered in the south gable wall, with one 6/6 to the left and a second door centered in the upper gable, flanked by diamond pattern ventilators in the brickwork. The first floor door opening has been heavily repaired but is presumably original. The window to the left of the first floor door appears to be cut in, while the second floor door opening appears to be original. The rakeboards have been replaced.

Brick kitchen & quarter from Southwest

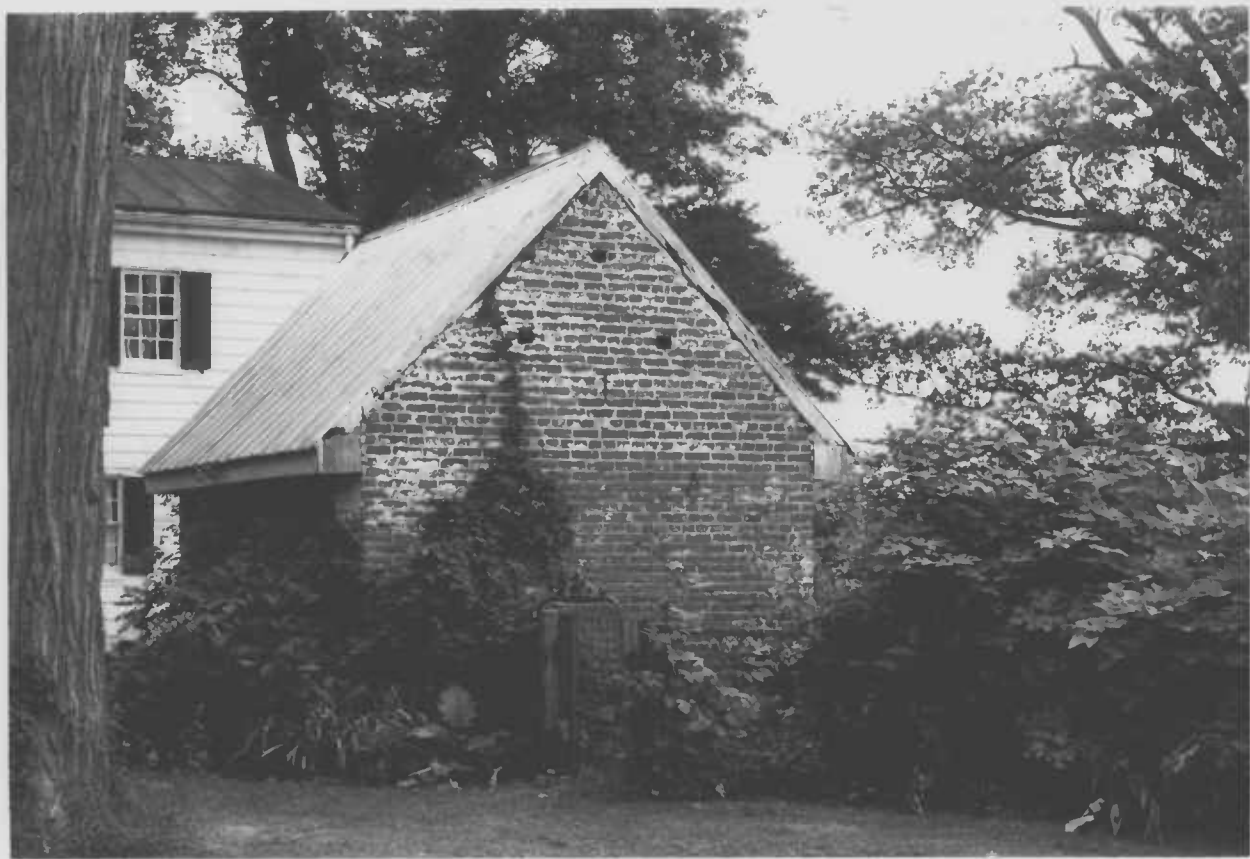
Located approximately 25 feet to the east of the wing is a brick meat house, 12 feet wide and 16 feet long. It has a pitched gable roof oriented on an east-west axis with a beaded batten door centered on the west gable wall. The brickwork is three course bond; the eaves are boxed in; the roof is covered with standing seam metal. One early beaded rakeboard has survived intact, the rest are badly weathered or replaced. There are three small vent holes in the upper gable of the east wall; similar holes in the west gable have been filled with bricks.

QA-230 Locust Grove
Centreville, Maryland
Orlando Ridout V 1981
Brick meat house

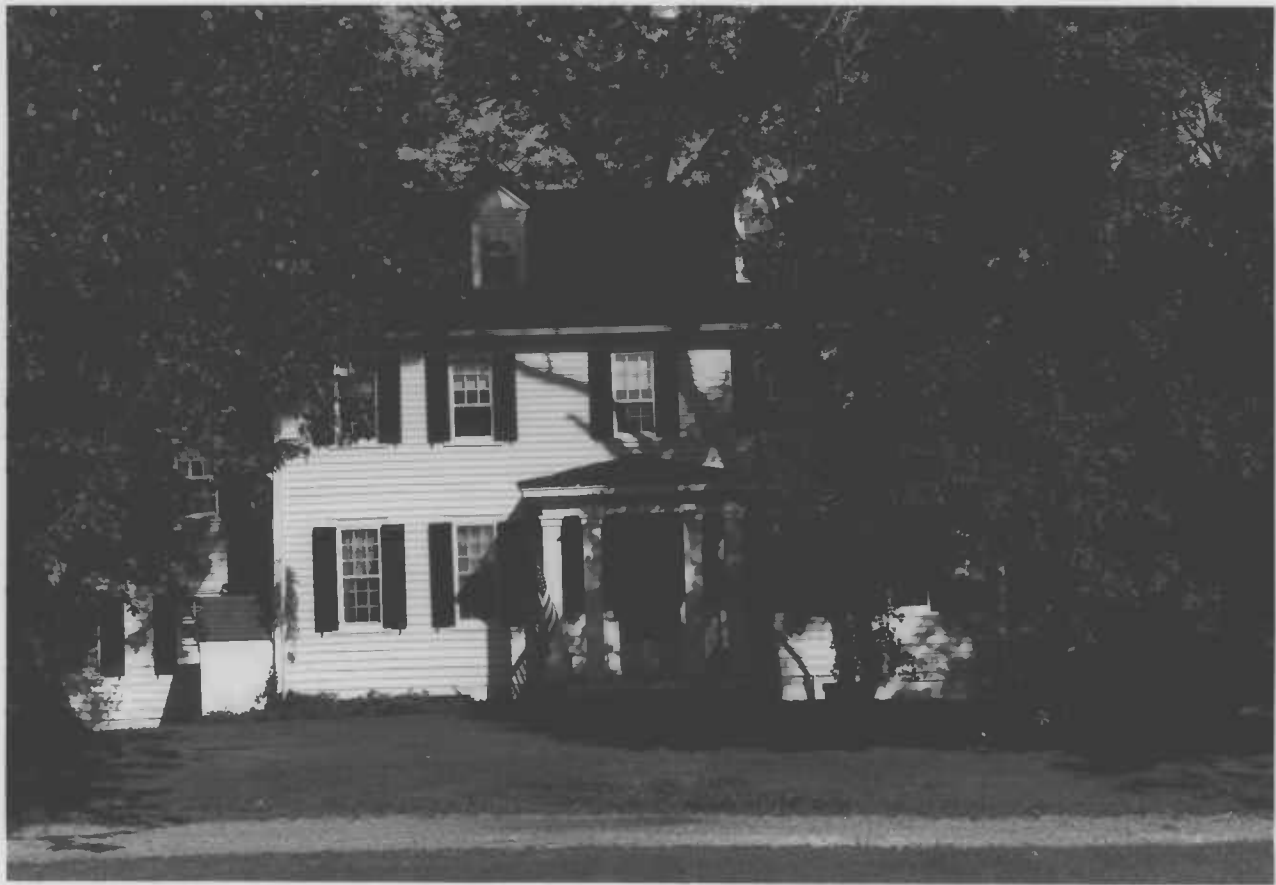
The front facade of the main house faces west, toward Centreville. The entrance is in the center bay, flanked by two 9/9 windows on each side. There are five 9/6 windows on the second floor and two 6/6 pitched roof dormers on the third floor. Two three-light cellar windows pierce the stuccoed brick foundation. The siding

Locust Hill
Centreville, Maryland
Orlando Ridout V 1980
Front facade from Northwest

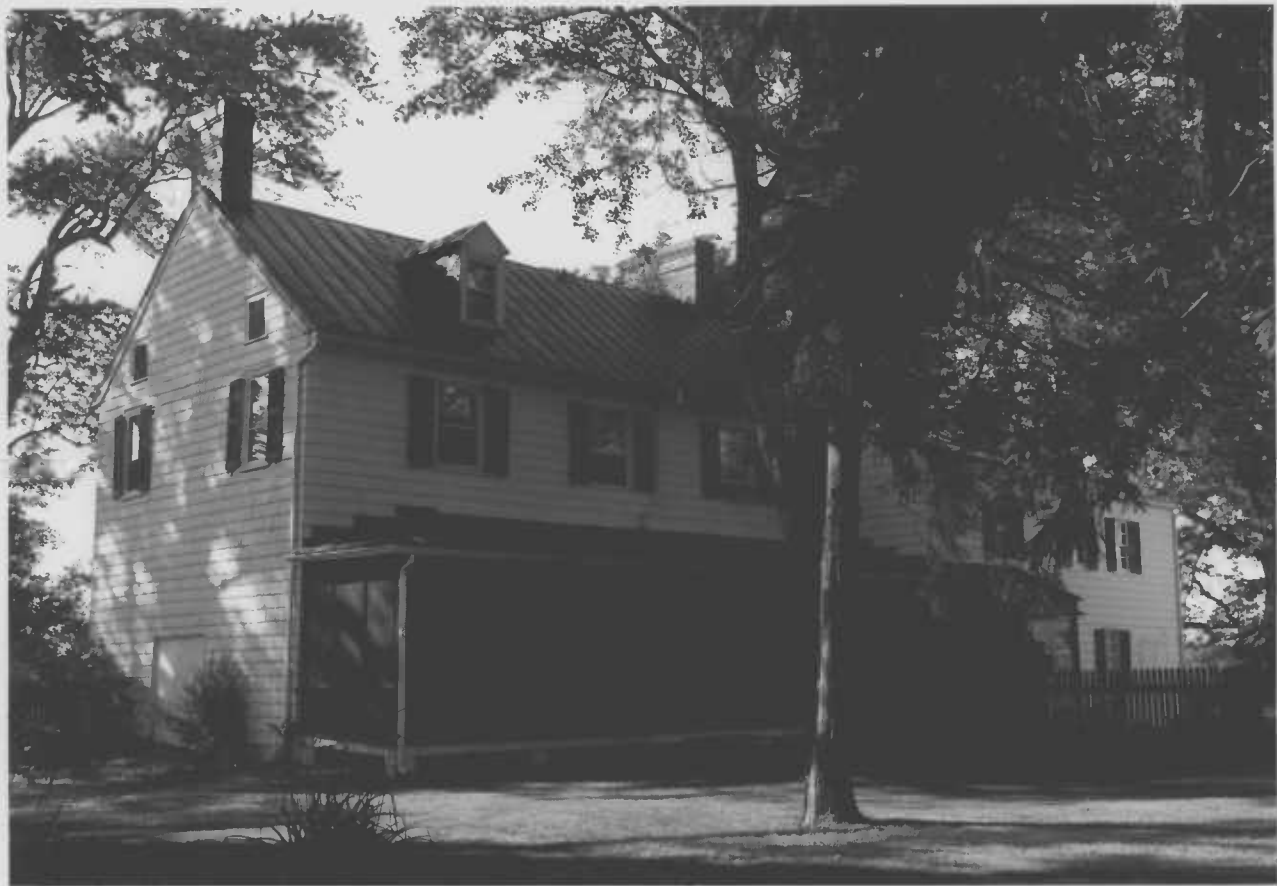
The fenestration on the rear or east facade is assymetrical. The door is offset to left of center due to the stair, and there are two 9/9 windows to the south and one to the north. Three 12/8 windows are ranged across the second floor, and a single 6/6 pitched roof dormer is offset to the south of the center bay on the third floor. The siding is wood shingle with a box cornice, the roof is standing-seam metal. A one story porch stretches across the entire facade.

Locust Hill
Centreville, Maryland
Orlando Ridout V 1980
Rear facade from Southeast

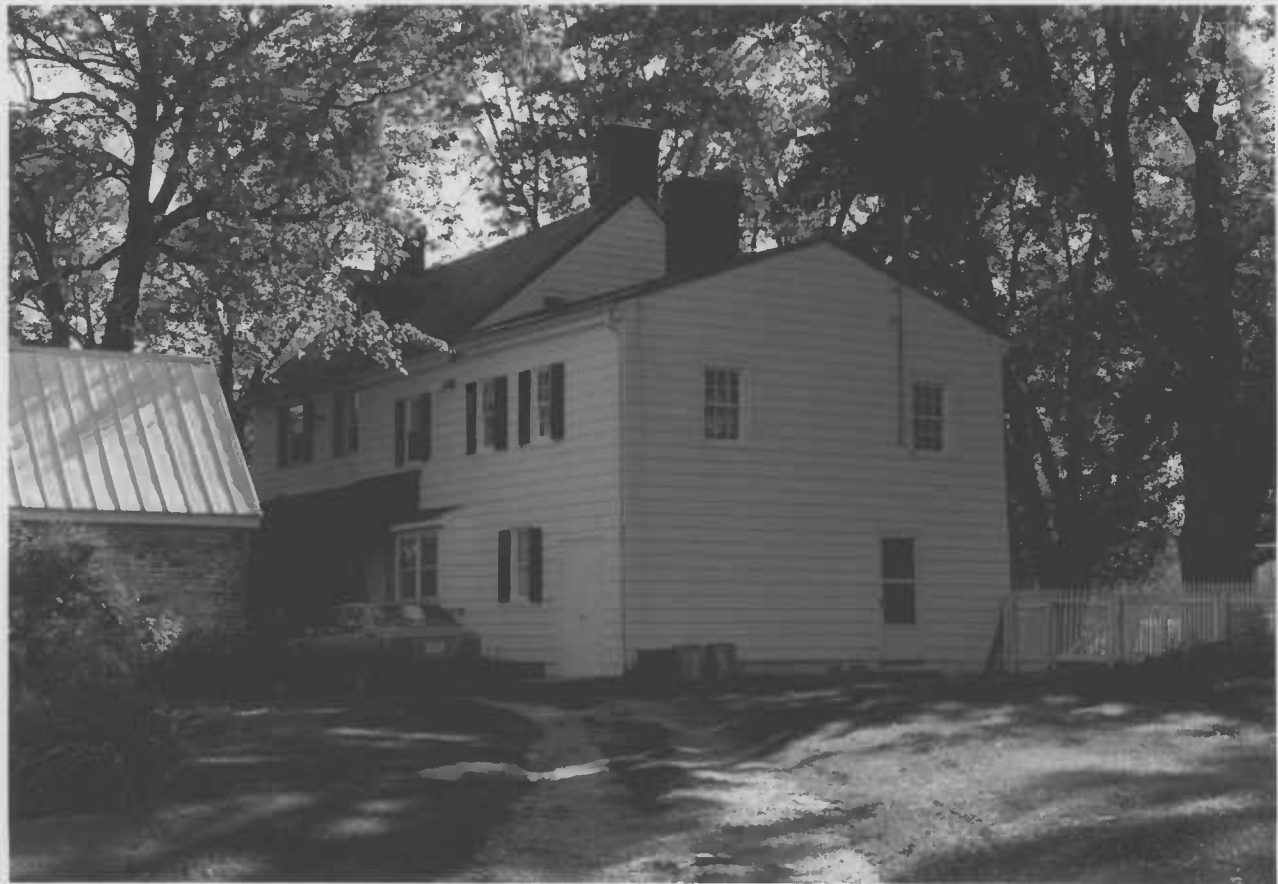
The wing is offset to the east, projecting out flush with the outer edge of the east porch of the main house. The wing has clearly evolved in several stages to its present form. The northwest portion of the wing is the earliest section, and evidently originally was a small single room plan building with a pitched roof and loft. A more complete description of this evolution is included in the interior description.

The fenestration of the east facade of the wing is asymmetrical. On the first floor, there is a door in the south bay and two 6/6 windows to the right. The north end of this facade is left open to the weather and serves as a wood storage area. Three 6/6 windows are ranged across the second floor. The wall is covered with wood shingle siding and a box cornice; the roof is standing seam metal.

Locust Hill
Centreville, Maryland
Orlando Ridout V 1980
House and wing from Northeast

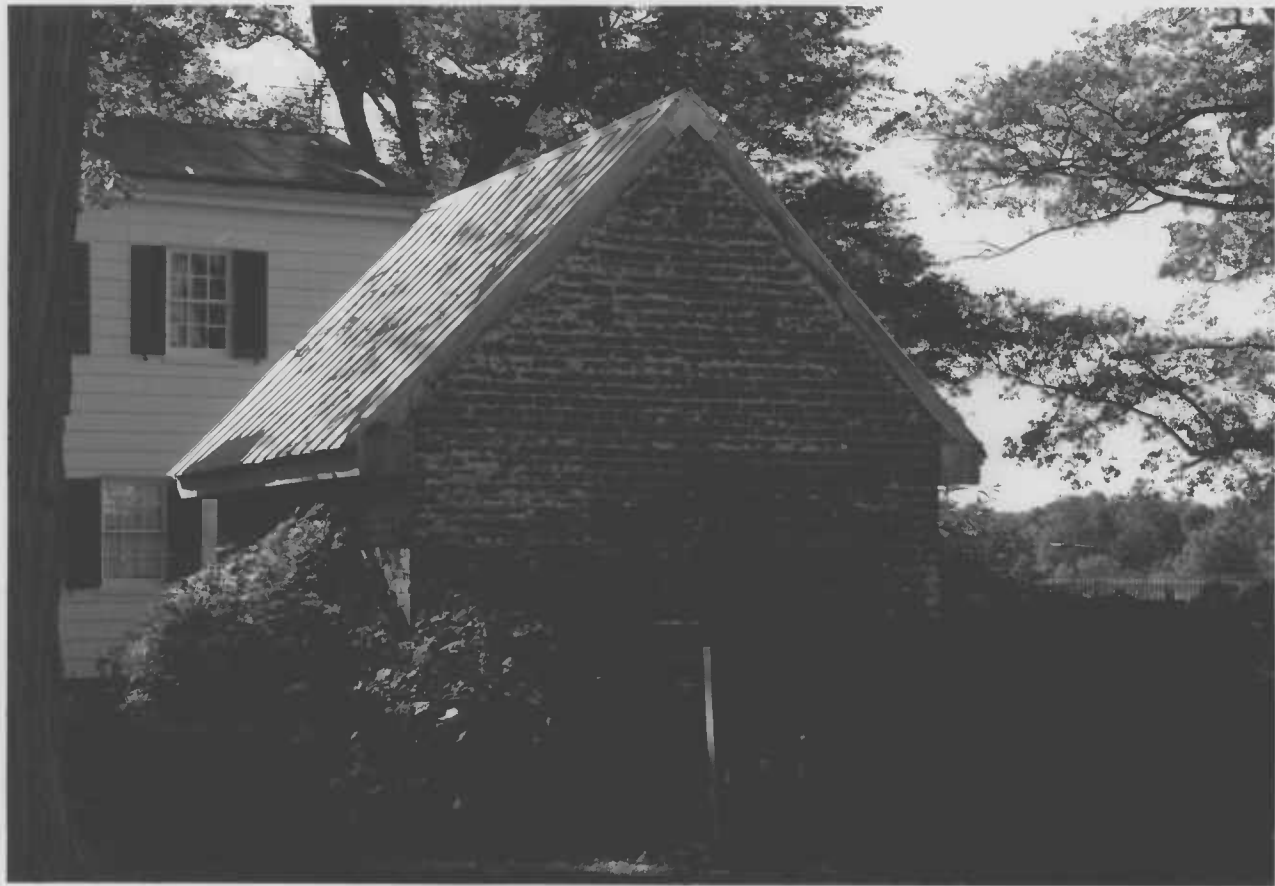
The interior has a dirt floor and open loft, with heavy smoke blackening on the interior walls and clear evidence that the curing fire was located in the southeast corner of the building. The common rafters are set relatively close together, with 10 rafter pairs in the 16 foot length of the roof. Six of the rafter pairs have lower collars and all 10 have upper collars.

Locust Hill
Centreville, Maryland
Orlando Ridout V 1980
Meat House
